Technical Notice

Product Name:	Status:
IPX-13S-RS-R40	Running change

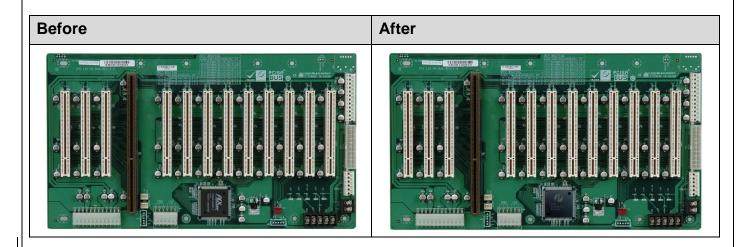
Due to the EOL of PLX PCI6150-BB66PC

Add Pericom PI7C8150BMAE as the substitute of PLX PCI6150-BB66PC.
