# Technical Notice

IPX-9S-RS-R41

# iEi Products Technical Notice

**Model Name: IPX-9S-RS-R41**

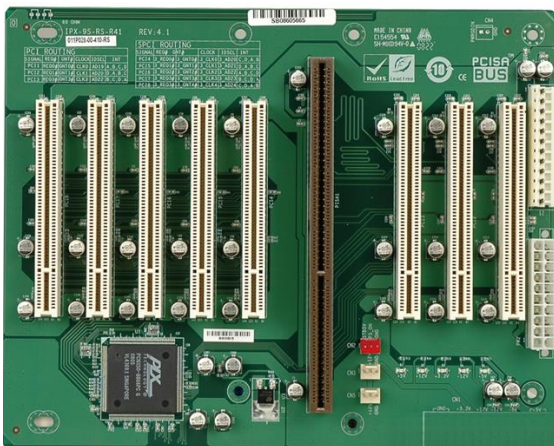
**Before**

Due to the EOL of PLX PCI6150-BB66PC

Add Pericom PI7C8150BMAE as the substitute of PLX PCI6150-BB66PC.

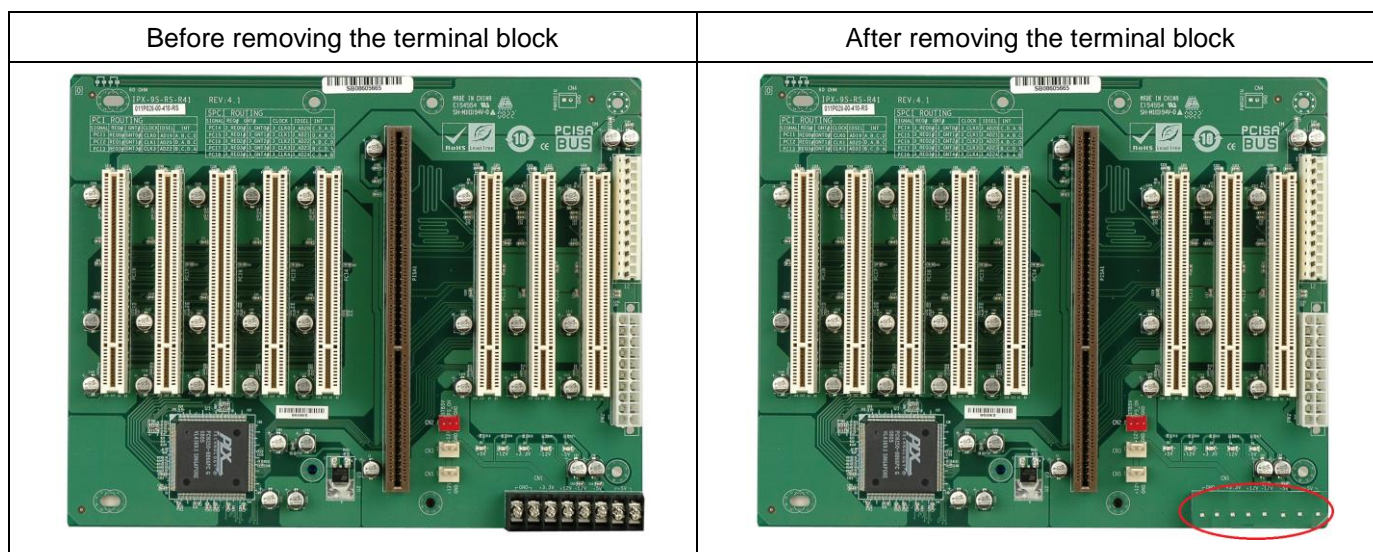
**R.E.: Terminal block 1\*8 DIP;180°;P:6.35mm;BLACK EOL**

iEi appreciate your daily support on IPC business. Due to EOL of the terminal block 1\*8 DIP, iEi will remove the Terminal block 1\*8 DIP from IPX-9S-RS-R41.

You can refer to the figure1 for the difference between before and after removing the terminal block

**Solution: Remove the terminal block**
